Design and execution of restoration work on a low-water crossing platform with a reinforced concrete structure

This study aims to take a descriptive approach to the entire process involved in restoring the Pau Ferro District Low-Water Crossing, located in Salgueiro,

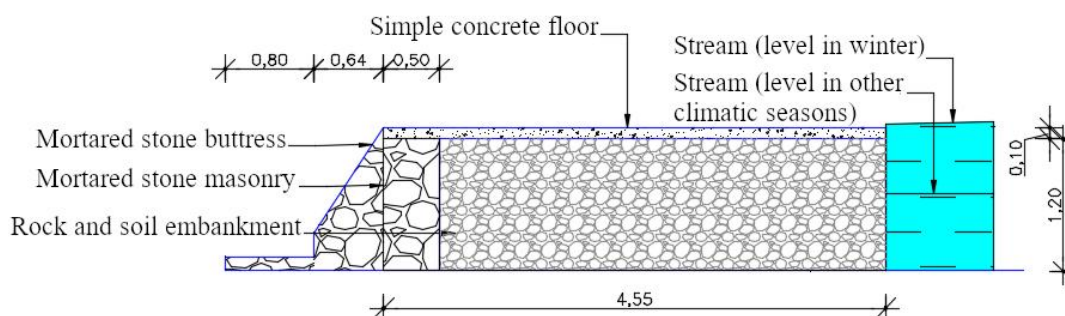
Figure 2 - Detail of a cross-section (at meter 41) of the Pau Ferro low-water crossing after renovations in the 1980s and 1990s, up to the year 2021, measurements in meters.

During the 1980s and 1990s, in addition to periodic maintenance, the crossing underwent more extensive repairs, including the addition of buttresses every 4 four meters, to the existing structural wall, as well as the installation of a simple concrete floor to replace the mortared gravel, as can be seen in Figure 2. This configuration of the low-water crossing remained in place until 2021, with only periodic maintenance.

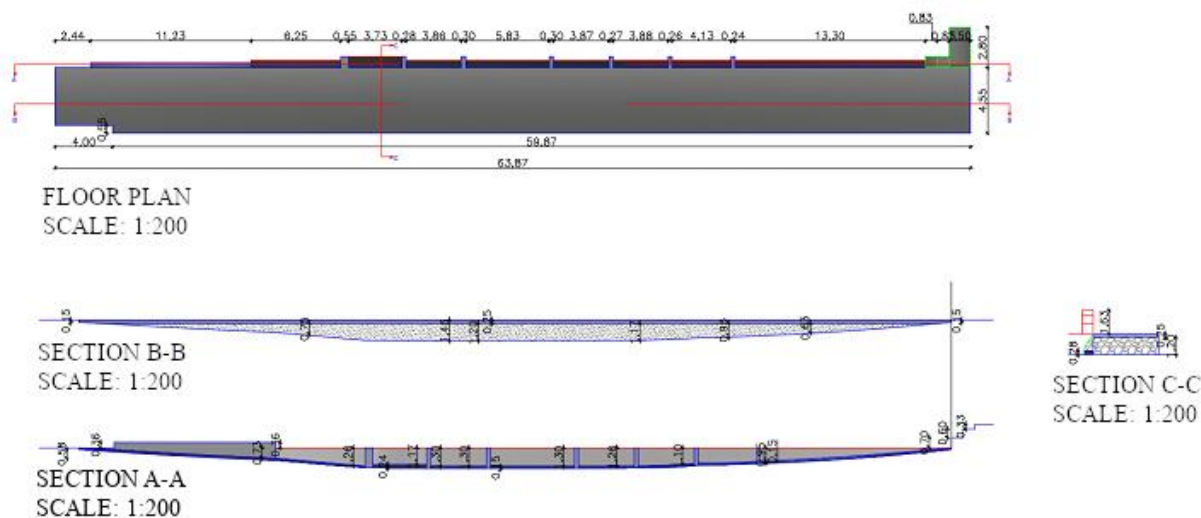
Figure 3 - Floor plan and sections as collected during the inspection, measurements in meters.

The road was highly deteriorated, making it difficult for motorcycles and pedestrians to pass. Accidents had already been reported at the site. The simple concrete floor had been worn down, mainly due to the high traffic of heavy vehicles and the constant flow of water, which had damaged it through the abrasion effect.

Part of the rockfill located between meters 60 and 64 had collapsed and, in some stretches along the roadway, slumping had occurred. The absence of a structural wall on the left-hand side, in the direction of Pau Ferro, was something notable, as it could not have been in full working order due to its size, being a rockfill, or partially rockfill, low-water crossing (since there was only one wall). Figure 3 shows a schematic of the crossing's sections and the situation observed during the inspection on January 20th, 2021.

The intervention selected would be a recovery and reinforcement project, in which the rockfill on one side would be removed, giving way to another structural wall of mortared stone masonry, forming a caisson with granular material in the middle. The ends would be blocked off with stones in the transverse direction, with mortared stone abutments having entrances that follow the tangent of the roadbed.

The deteriorated concrete floor would be completely removed, along with the layer of gravel still present from other renovations. The rockfill would be excavated to a certain depth, replacing some of the material with compacted sand to allow for the inclusion of a structured platform or superstructure of longitudinal and transverse beams and central slabs.
